**Washington Department of Ecology  
Hazardous Waste & Toxics Reduction Program  
Compliance Report**

**Site: John Henry Mine, Pacific Coast Coal**

Inspection Date: May 18, 2007  
Site Contacts: David Morris, General Manager  
Phone: (360) 886-1060  
Mailing Address: PO Box 450, Black Diamond, WA 98010  
Site Location: Black Diamond, WA  
At This Site Since: 1985  
Generator/Site Status: No RCRA Site ID number

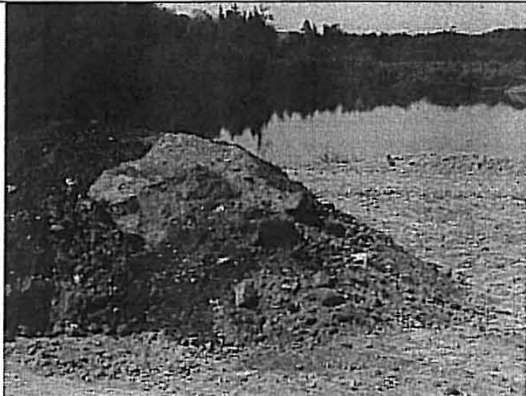
<b>Pit #1 Area</b>  (Photo # 1 / 30, Disk 1 of 2 10:48 am)	Load of bricks and other material near Pit #1. The lake currently in Pit #1 is visible in the photo.

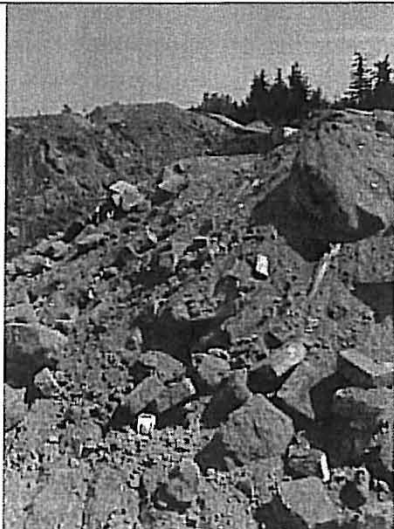
<b>Pit #1 Area</b>  (Photo # 25 / 30, Disk 1 of 2 10:57 am)	Concrete, bricks, and dirt make up some piles.  Picture rotated

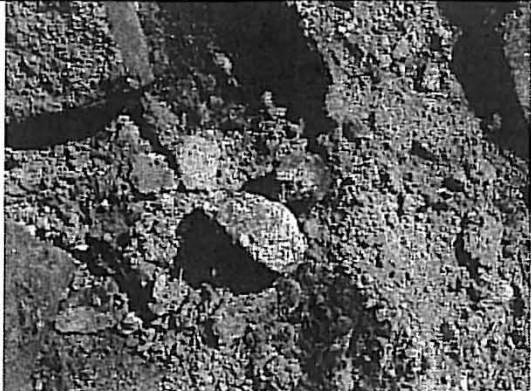
Sample #3 was a used brick that was black, dark golden-yellow, gray and white. The brick in photo #29 is similar to the material in Sample #3.

<b>Pit #1 Area</b>  (Photo # 29 / 30, Disk 1 of 2 11:13 am)	Brick is deteriorating. Similar to brick in Sample #3.

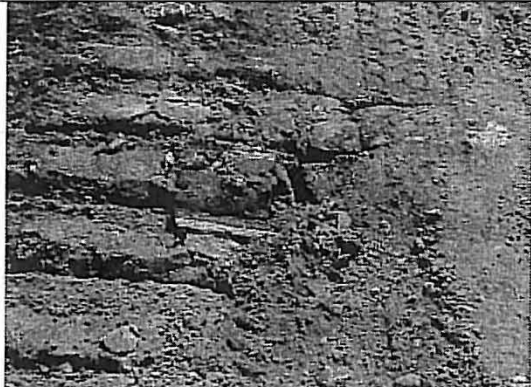
Some of the bricks were crumbling and deteriorating. This deterioration appeared to be caused either from exposure to weather and/or being driven over by trucks and other equipment (see photo 1 below).

(Photo # 1 / 7, Disk 2 of 2 11:21 am)	Brick deteriorating after being graded and after heavy vehicular traffic usage.
